## Report of Findings

Light Sport Aviators Drainage Evaluation  
Style: Get Inspired Flight, Inc. et al v. David G. Cobb et al  
State Court of Cherokee County Georgia Cause No. 21SCE0195

Rimkus Matter No: 100230555

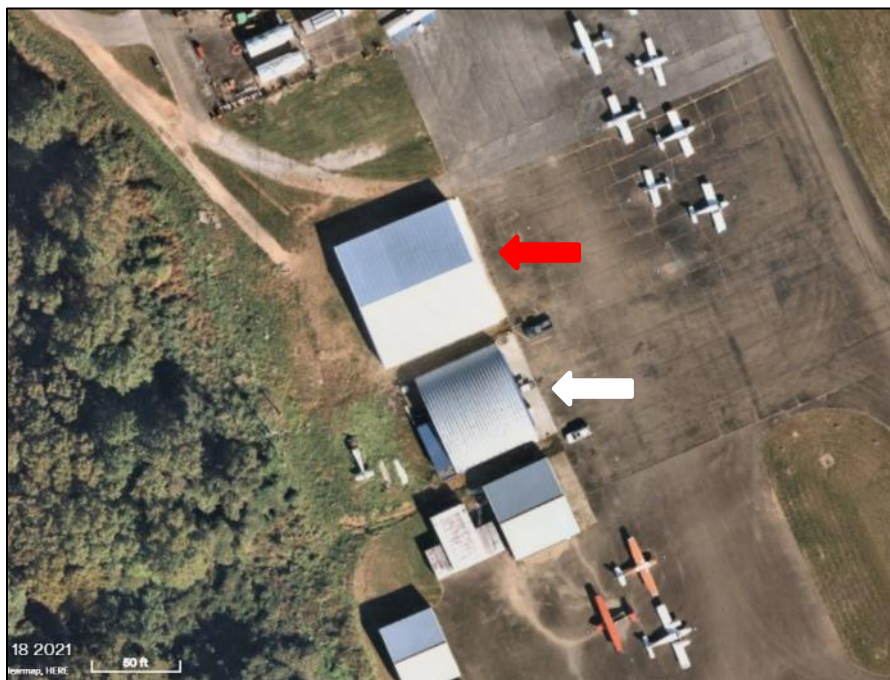
**Figure 1** - 2021 aerial view of the hangars from NearMap. The Cobb hangar is marked with a white arrow, and the LSA hangar is marked with a red arrow.

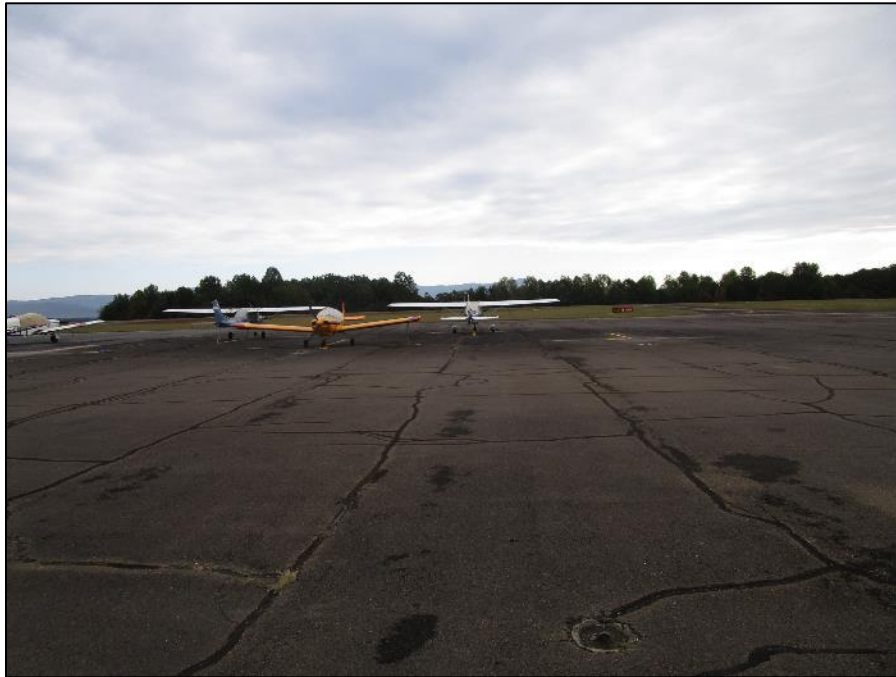
**Photograph 3**

- East of the hangars was a large, paved tarmac/aircraft parking area. The paved area sloped downward to the west, directing surface water flow toward the hangars (**Photographs 3 and 4**).
- In front of the LSA hangar was a concrete apron.

East of the hangars was a large, paved tarmac/aircraft parking area. The paved area sloped downward to the west, directing surface water flow toward the hangars.

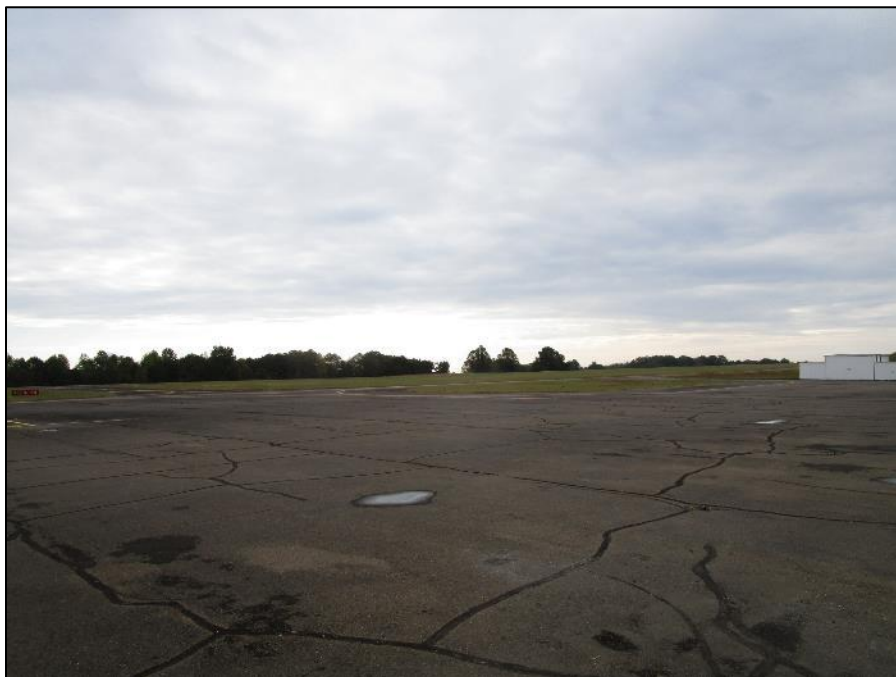
**Photograph 4**

East of the hangars was a large, paved tarmac/aircraft parking area. The paved area sloped downward to the west, directing surface water flow toward the hangars.

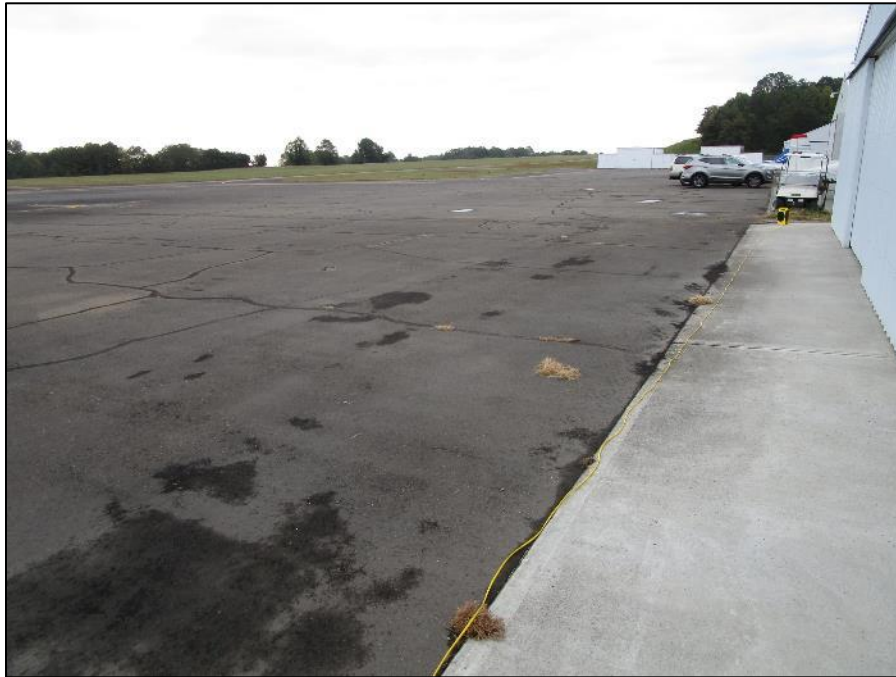
**Photograph 5**

- The concrete apron sloped down from the hangar floor to the pavement approximately 2.2 inches (**Photograph 5**). The apron directed water flow from the pavement around both sides of the hangar.

The concrete apron sloped down from the hangar floor to the pavement approximately 2.2 inches.

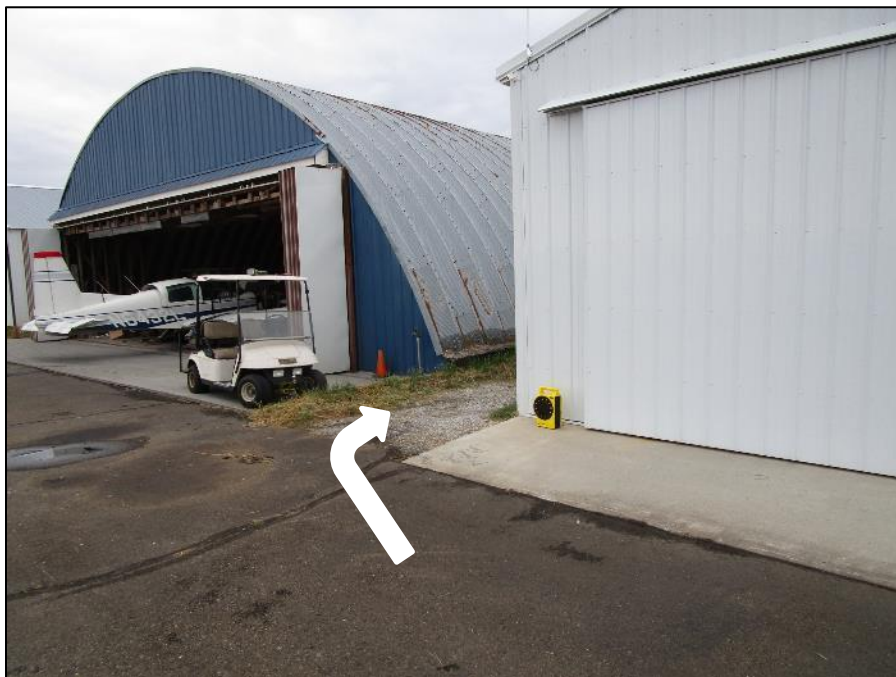
**Photograph 6**

- The LSA and Cobb hangars were approximately 8 feet apart. The westward surface water flow, diverted by the concrete apron, was directed to a drainage ditch between the hangars (**Photograph 6**). The drainage ditch had a constant slope to the west and discharged surface water west of the hangars (**Photographs 7 through 9**).

The westward surface water flow, diverted by the concrete apron, was directed to a drainage ditch between the hangars.

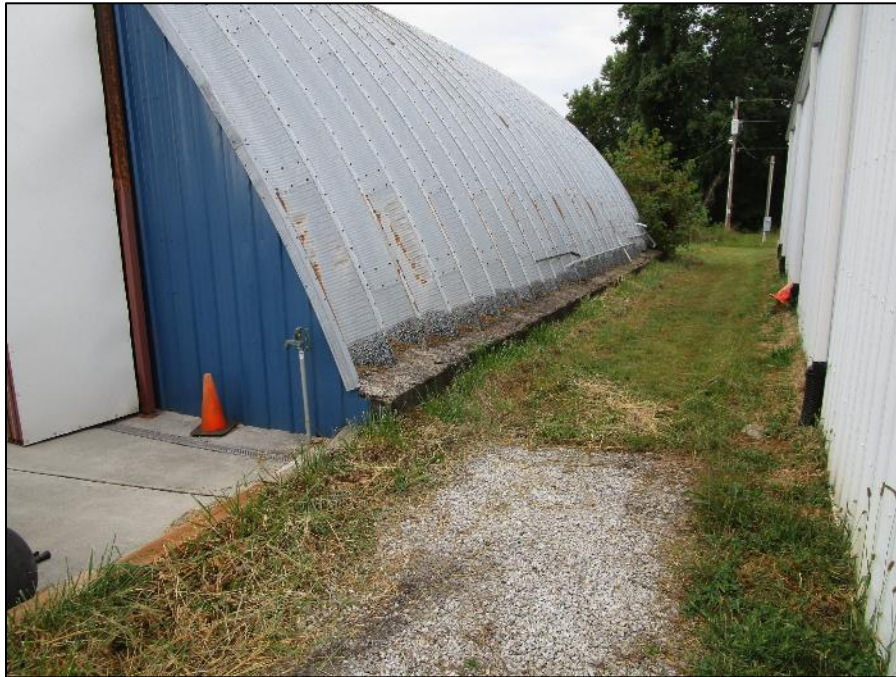
**Photograph 7**

The drainage ditch had a constant slope to the west and discharged surface water west of the hangars.

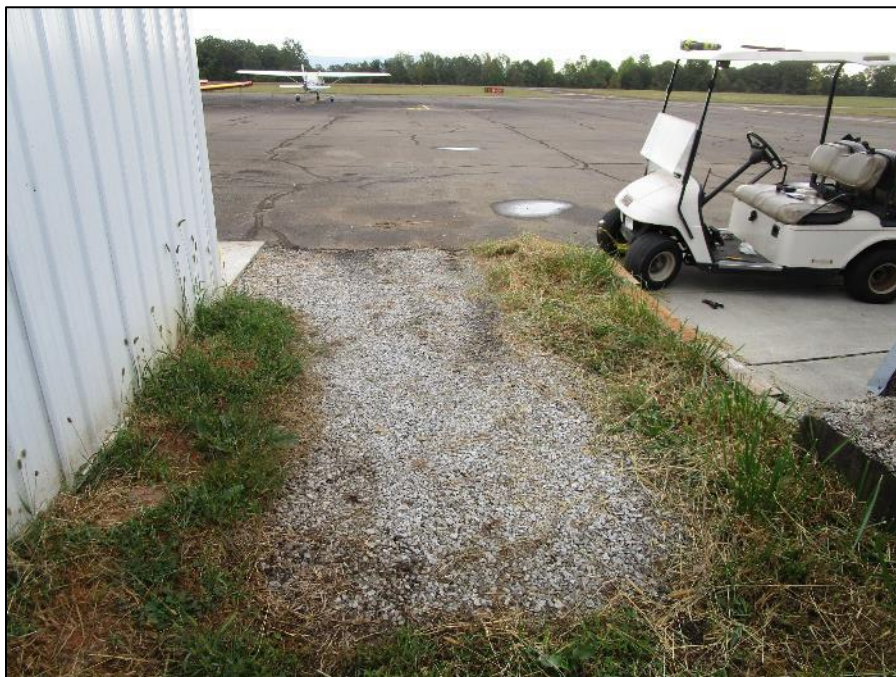
**Photograph 8**

The drainage ditch had a constant slope to the west and discharged surface water west of the hangars.

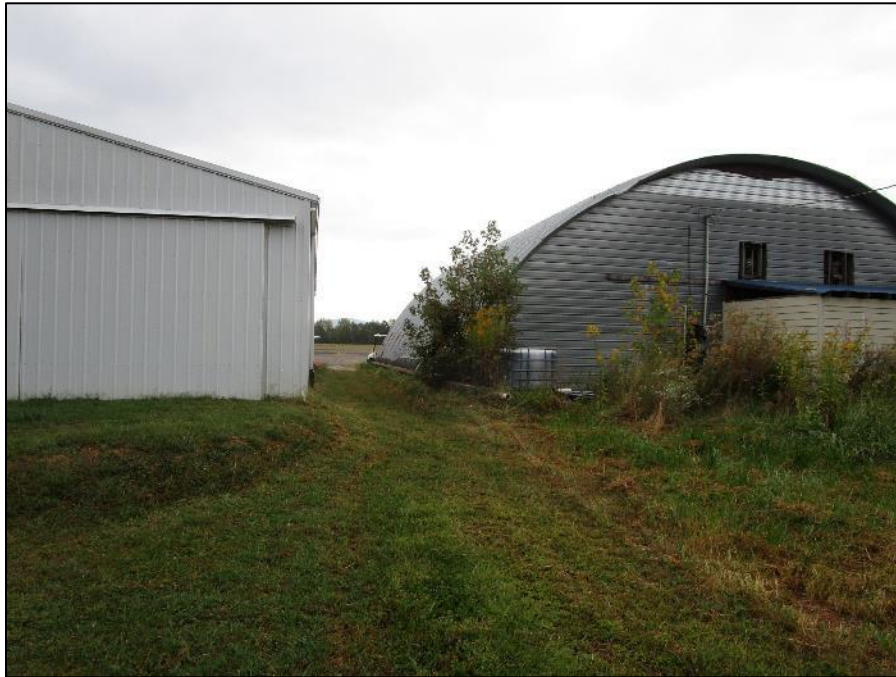
**Photograph 9**

The drainage ditch had a constant slope to the west and discharged surface water west of the hangars.

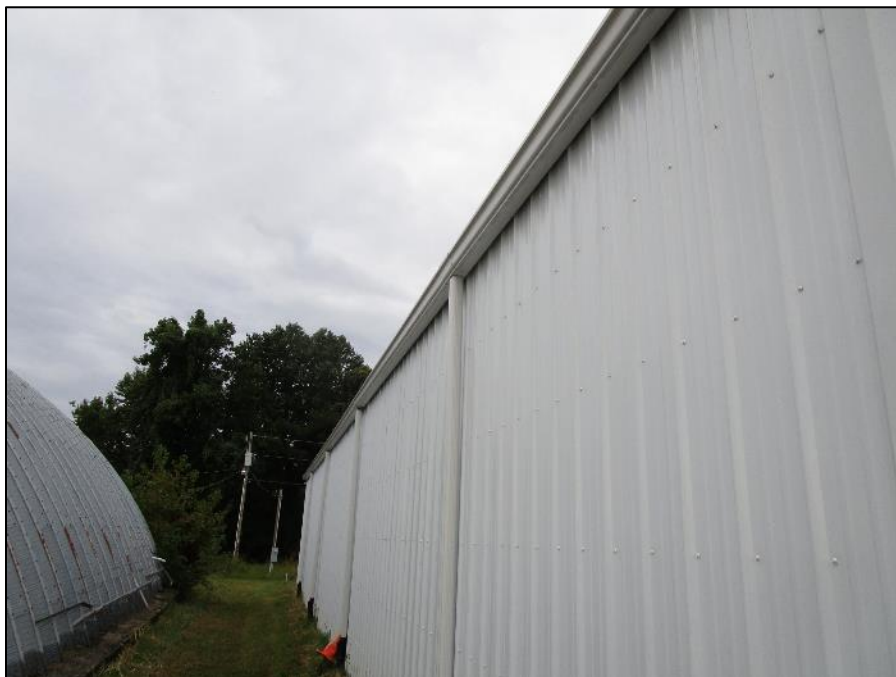
**Photograph 10**

- A gutter with downspouts and buried extensions captured and transported roof runoff from the LSA hangar to the west (**Photograph 10**).
- The floor of the Cobb hangar was approximately 6.6 inches lower than the floor of the LSA hangar.

A gutter with downspouts and buried extensions captured and transported roof runoff from the LSA hangar to the west.

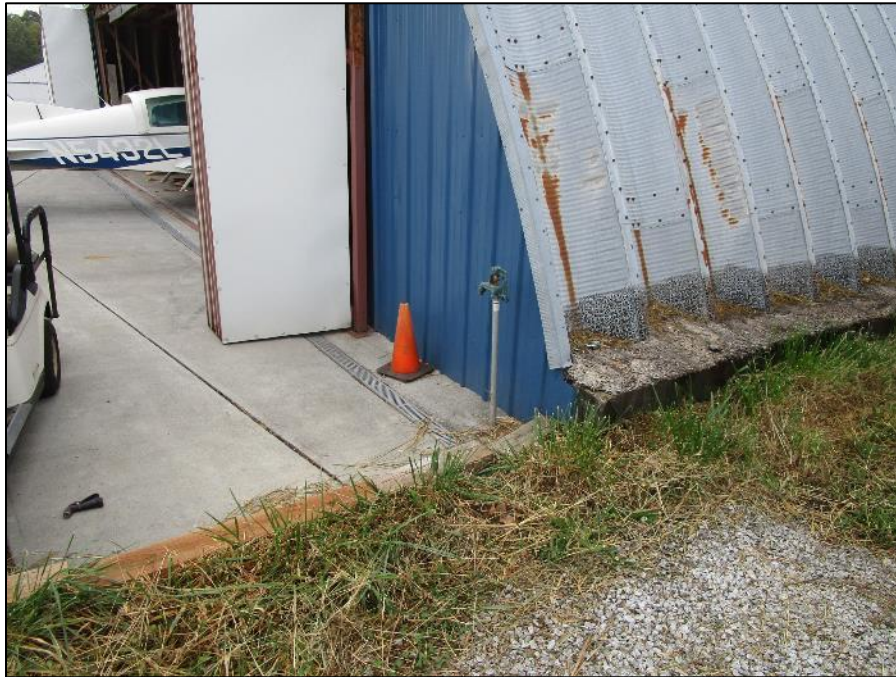
**Photograph 11**

- The floor of the Cobb hangar was approximately 4.4 inches lower than the edge of the paved tarmac (**Photograph 11**).
  - There was a concrete apron in front of the Cobb hangar that sloped down to a 4-inch-wide trench drain installed in the apron in front of the hangar (**Photographs 12 and 13**).

The floor of the Cobb hangar was approximately 4.4 inches lower than the tarmac pavement in front of the building. The concrete apron in front of that building sloped downward from the tarmac pavement to the building, and a significant amount of water runoff was directed directly against the building. This was an inherently problematic configuration. The elevations of the pavement, apron, and hangar floor relied exclusively on a trench drain installed in the apron to capture that water and convey it to the drainage ditches located north and south of the Cobb hangar. It was apparent that the trench drain was inadequate to manage the water that was coming off the tarmac. Additionally, photographs showed that the drain pipe from the north side of the trench drain was not maintained, which further diminished the capacity of the trench drain. The surface water intrusion into the Cobb hangar was a long-term occurrence resulting from the lack of surface water control features in front of the Cobb hangar.

The floor of the Cobb hangar was approximately 4.4 inches lower than the edge of the paved tarmac.

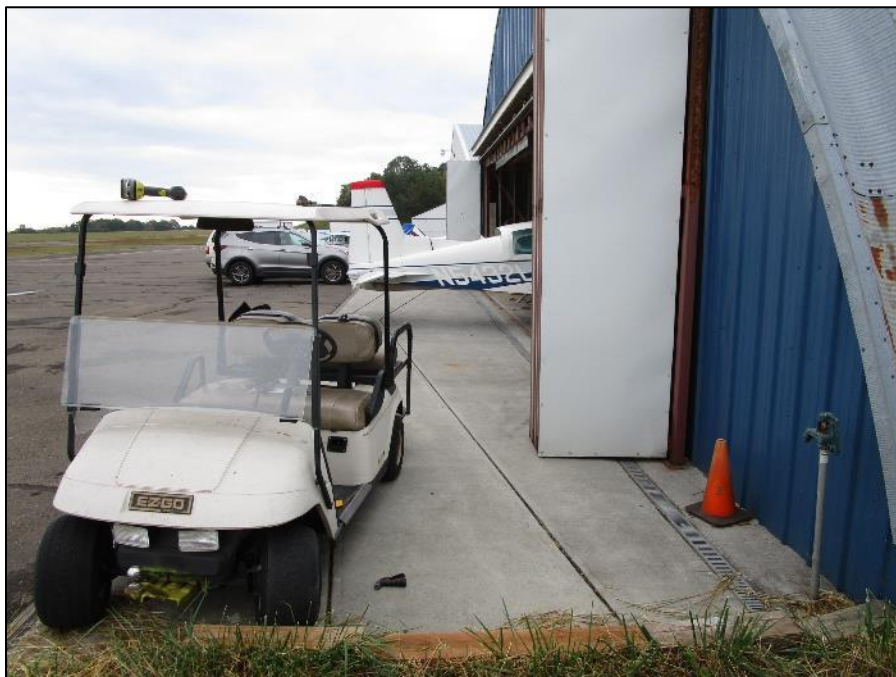
**Photograph 12**

There was a concrete apron in front of the Cobb hangar that sloped down to a 4-inch-wide trench drain installed in the apron in front of the hangar.

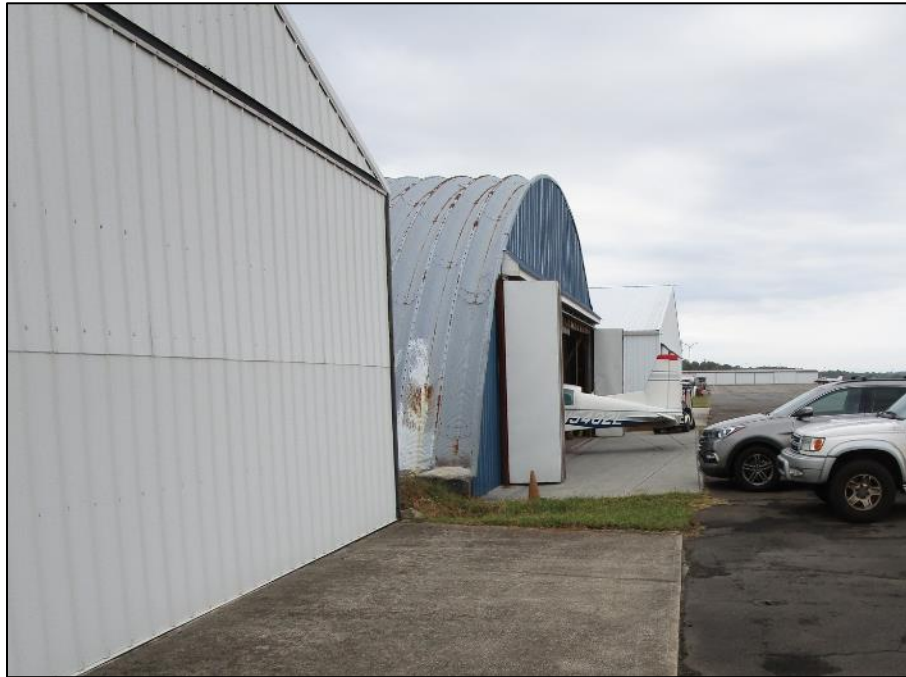
**Photograph 13**

There was a concrete apron in front of the Cobb hangar that sloped down to a 4-inch-wide trench drain installed in the apron in front of the hangar.

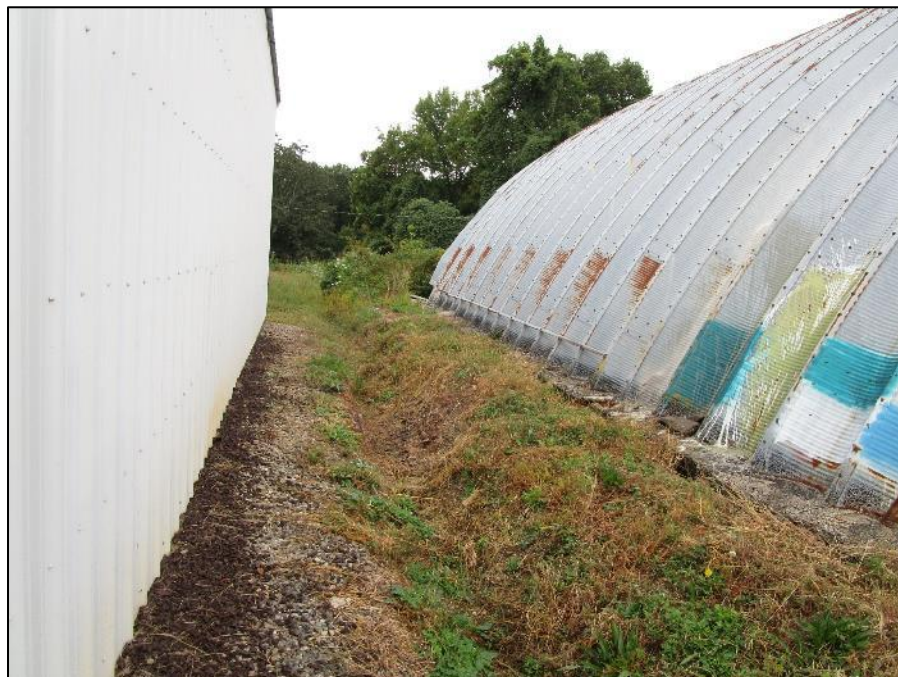
**Photograph 14**

- Similar to the LSA hangar, there was a trench between the Cobb hangar and the adjacent hangar to the south that carried surface water to the west (**Photograph 14**). A 4-inch polyvinyl chloride (PVC) drain pipe from the trench drain discharged into that ditch (**Photographs 15 and 16**).

Similar to the LSA hangar, there was a trench between the Cobb hangar and the adjacent hangar to the south that carried surface water to the west.

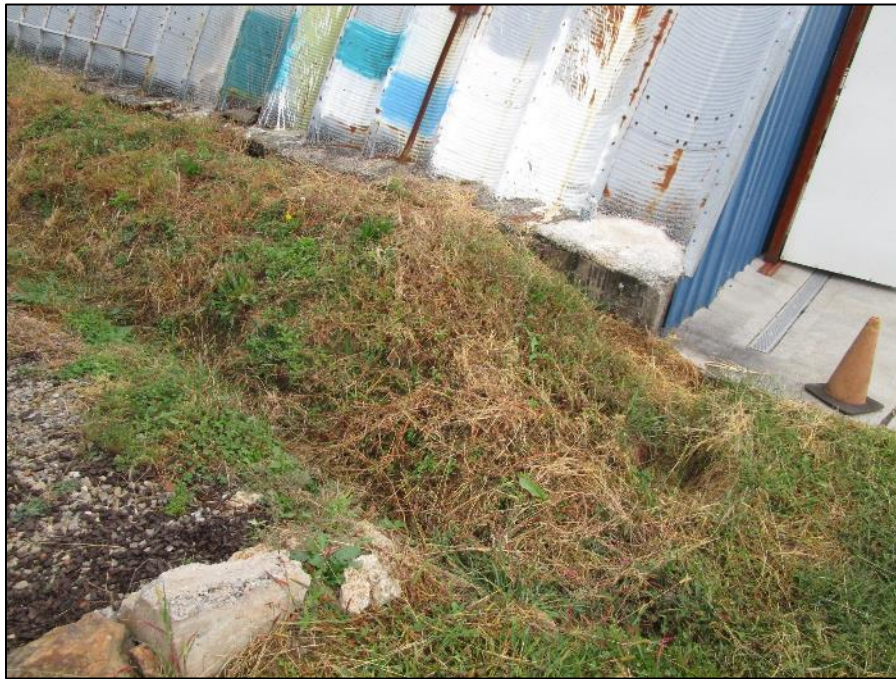
**Photograph 15**

A 4-inch PVC drain pipe from the south end of the trench drain discharged into that ditch.

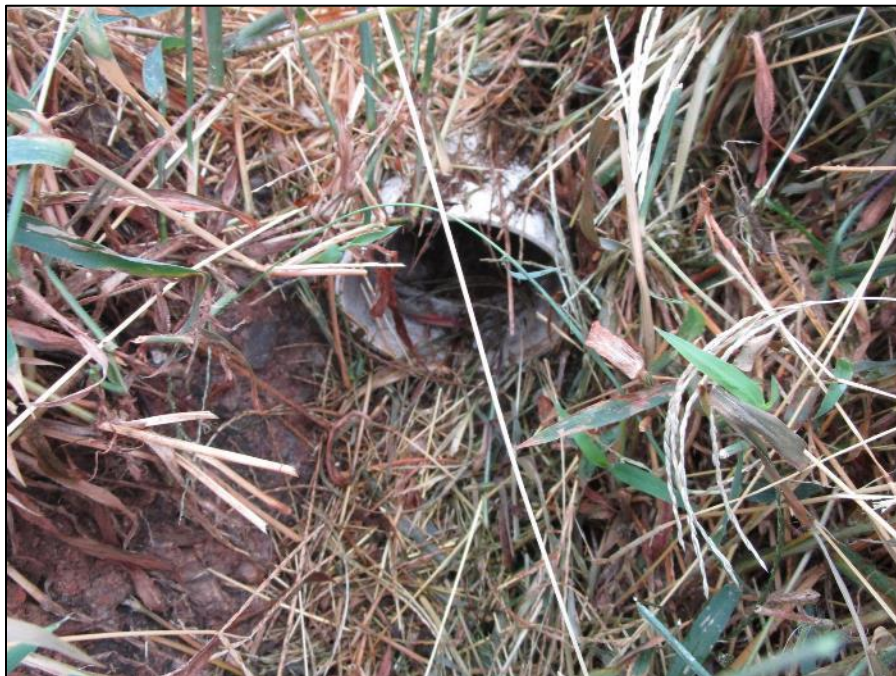
**Photograph 16**

A 4-inch PVC drain pipe from the south end of the trench drain discharged into that ditch.

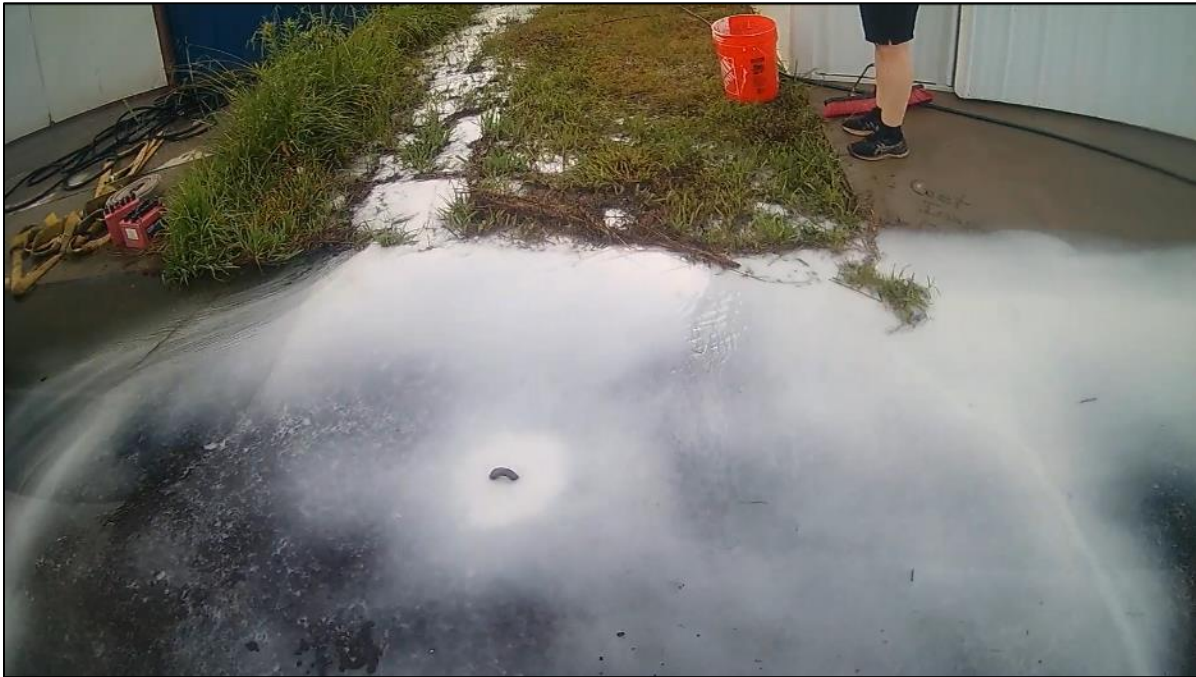
**Photograph 17 – Provided by Ms. Laura Thorburn-Gundlach from LSA**

Videos taken during rain events with dye added to the water runoff showed the runoff diverted around the LSA hangar running into the ditch and not the Cobb hangar.

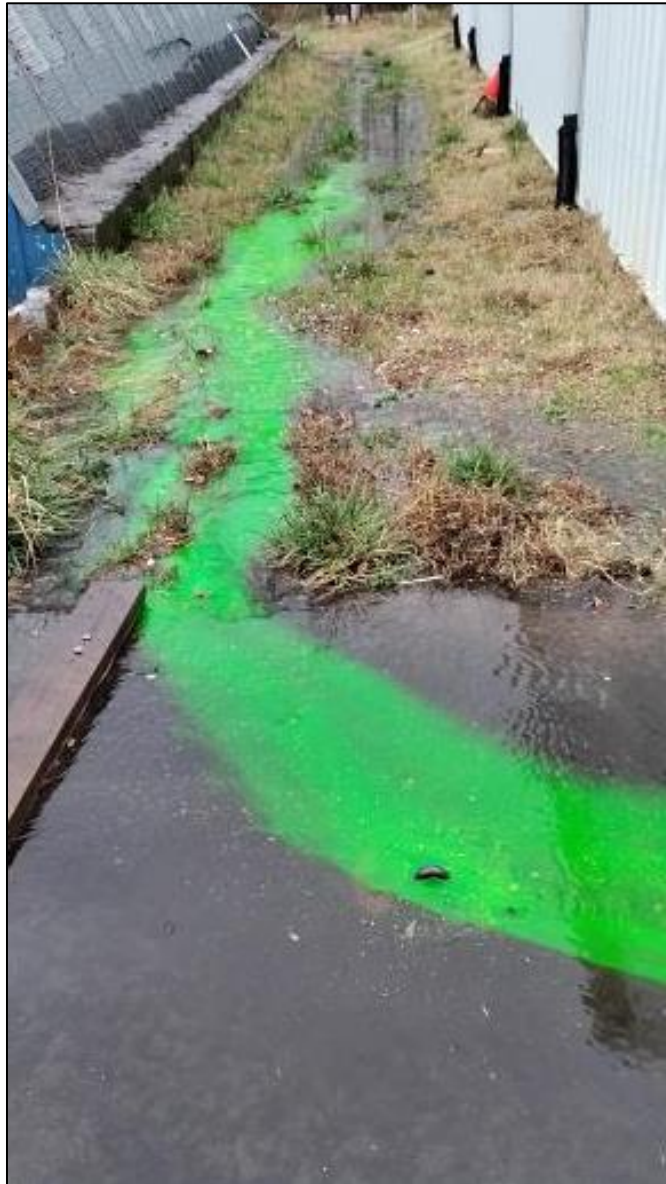
**Photograph 18 – Provided by Ms. Laura Thorburn-Gundlach from LSA**

Videos taken during rain events with dye added to the water runoff showed the runoff diverted around the LSA hangar running into the ditch and not the Cobb hangar.

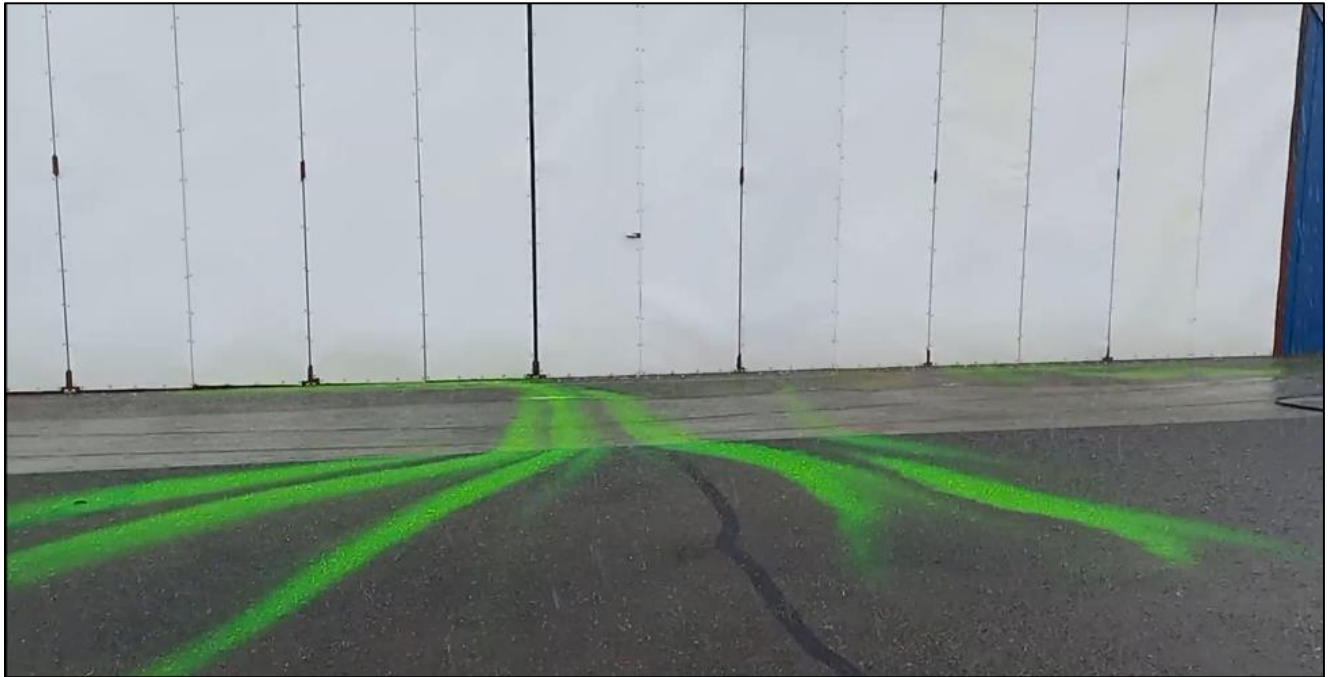
**Photograph 19 – Provided by Ms. Laura Thorburn-Gundlach from LSA**

Videos taken during rain events with dye added to the water runoff showed water running directly toward the Cobb hangar and accumulating against the door.

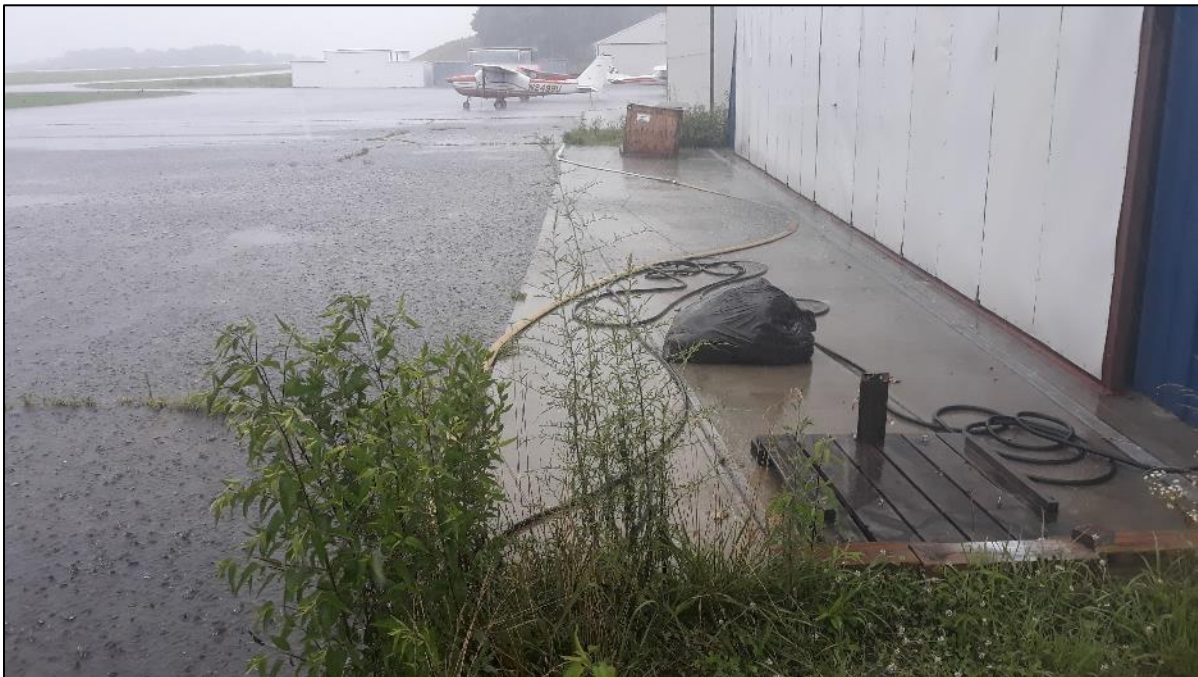
**Photograph 20 – Provided by Ms. Laura Thorburn-Gundlach from LSA**

- Mr. Johnson provided no opinions or analysis of the adequacy of the trench drain before the LSA hangar was constructed. It was apparent just by observation that the drain was inadequate to handle the large volume of water from the tarmac.

Multiple photographs and videos showed water accumulating over the top to the trench drain at the Cobb hangar.

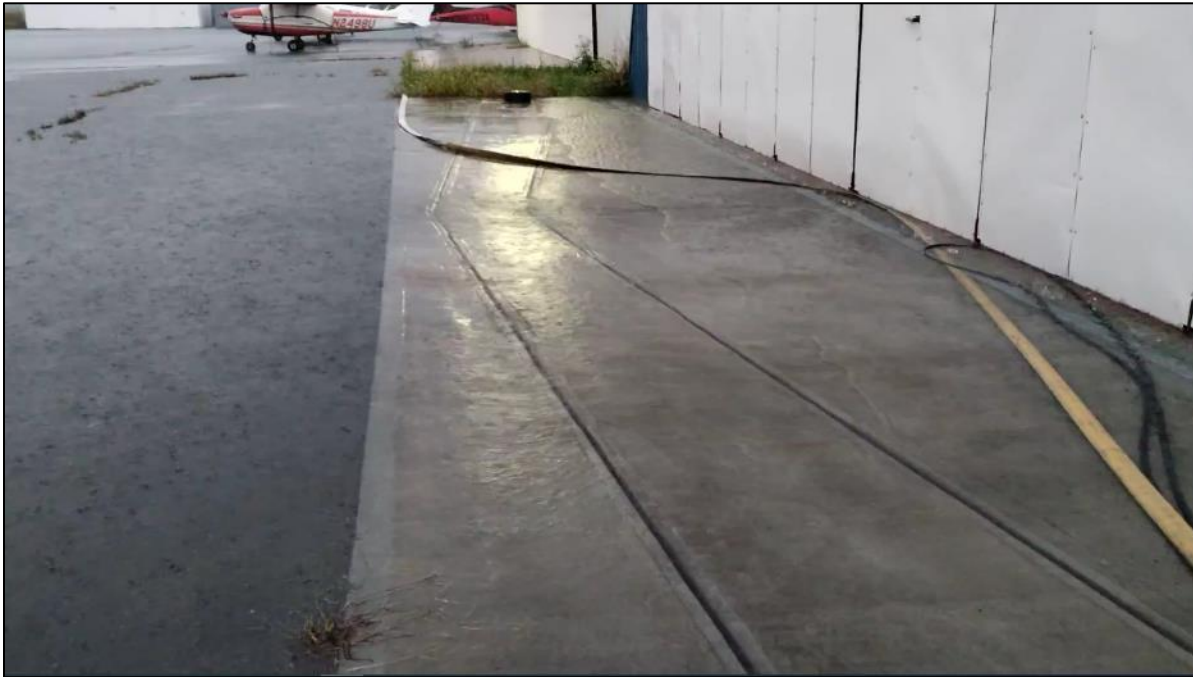
**Photograph 21 – Provided by Ms. Laura Thorburn-Gundlach from LSA**

Multiple photographs and videos showed water accumulating over the top to the trench drain at the Cobb hangar.

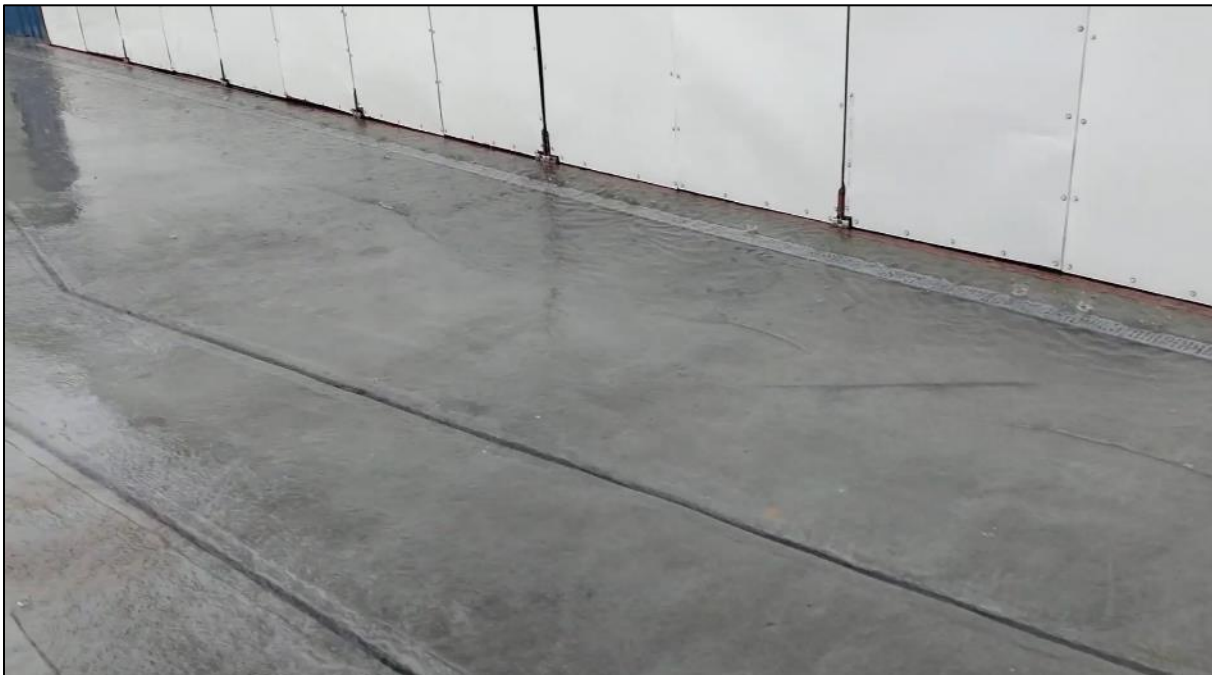
**Photograph 22 – Provided by Ms. Laura Thorburn-Gundlach from LSA**

Multiple photographs and videos showed water accumulating over the top to the trench drain at the Cobb hangar.

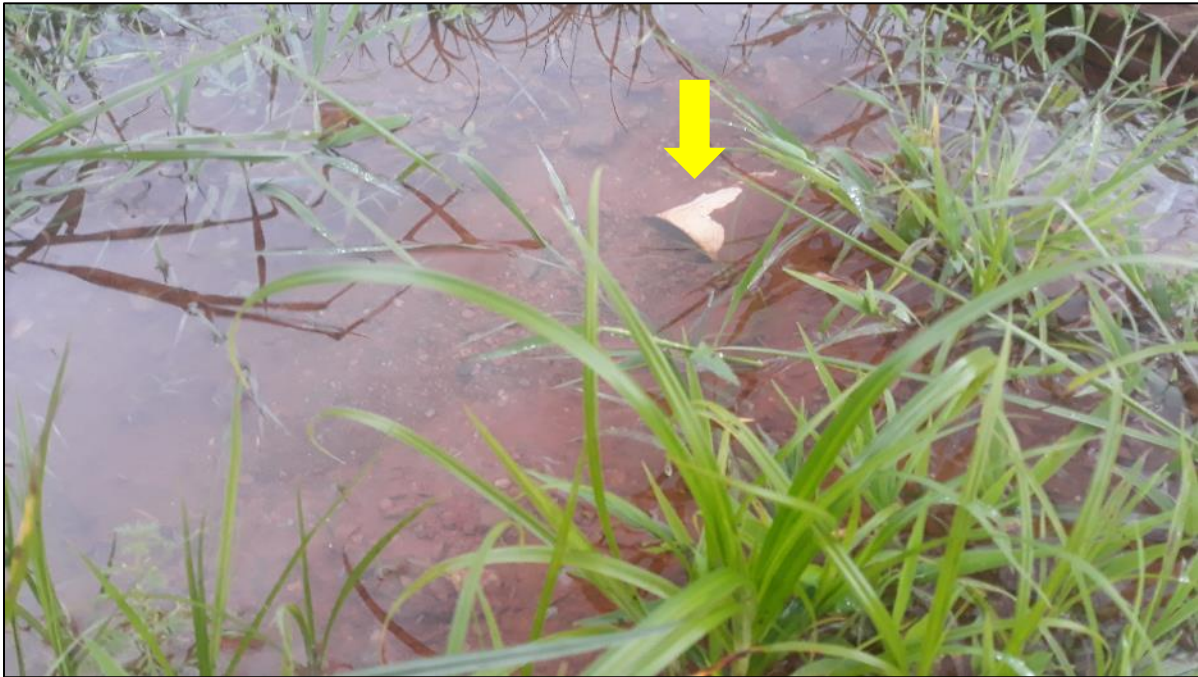
**Photograph 23 – Provided by Ms. Laura Thorburn-Gundlach from LSA**

- Multiple photographs and videos showed water accumulating over the top to the trench drain at the Cobb hangar (**Photographs 20 through 22**).
- Photographs showed the discharge pipe from the north side of the trench drain at the Cobb hangar to be full of mud and fully submerged in water (**Photograph 23**).

Photographs showed the discharge pipe from the north side of the trench drain at the Cobb hangar to be full of mud and fully submerged in water.
