September 27, 2023

**Re: Pickens County Airport Hangar Drainage Issue
Update to Sept 2022 Correspondence**

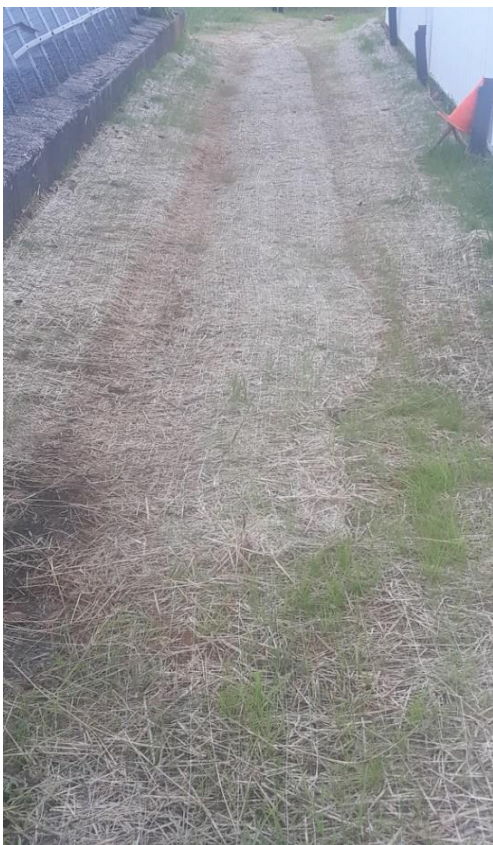
The management of runoff of stormwater depends largely on maintenance of the swale. If weeds or other factors are allowed to grow in the swale, the flow conditions will change and the swale capacity will be significantly diminished. Below is a photo of the swale area taken some time in 2021, following Light Sport Aviators construction and in 2022, showing the unmaintained condition of the channel.

After Light Sport Aviators Construction - 2021

We are not certain of the horizontal limits of ownership of each hangar or the stipulations of responsibility by the Pickens County Airport agreements with the owners. From our point of view, the responsibility to maintain the swale appears to fall on the entity having ownership of the area between the two hangars. In addition to maintaining the condition of the flow line of the swale, it appears that any obstacle allowed at the point where water leaves the tarmac and enters the swale will create a potential diversion of water away from the swale. Removing any 'lip' of soil or grass that extends vertically above the point where asphalt and the swale connect is imperative to prevent a 'dam' effect and cause water to bypass or pool at the entrance to the swale.

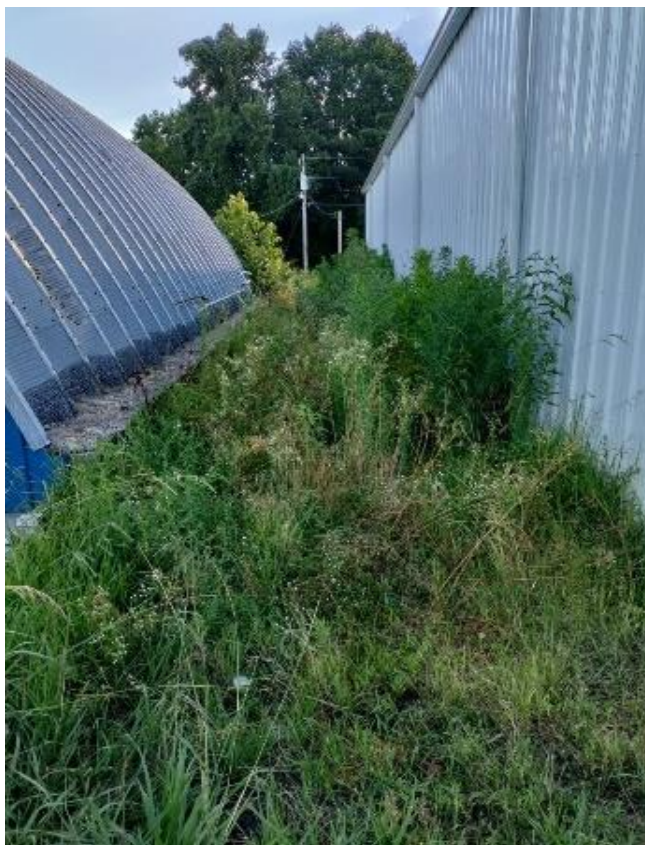
Neglected Maintenance - 2022
